Effects of Sub-Grade and Sub-Base Materials Quality on Flexible Pavement: A Case Study

Getu Tamiru, Palani Ponnuramam

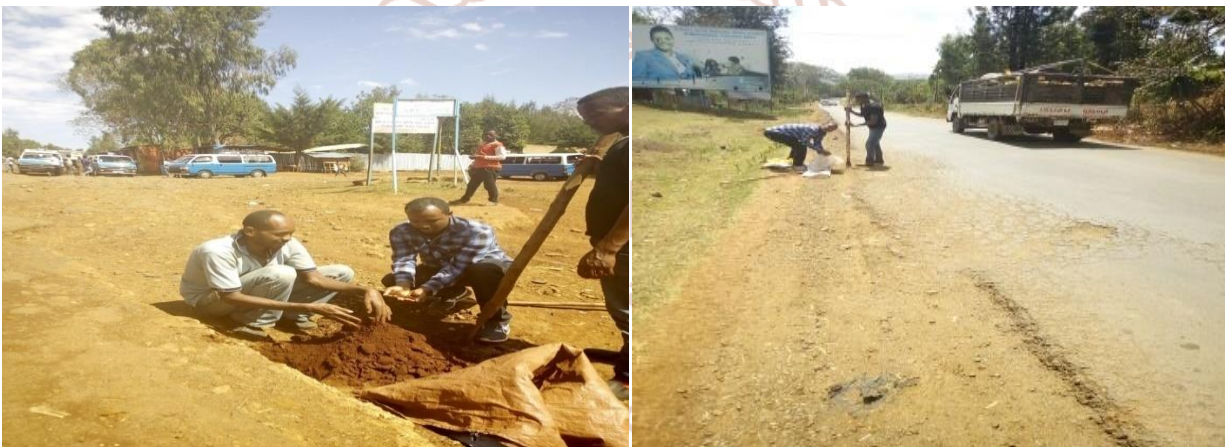
Fig 2: Sample extracted photos captured date 08/04/2017@3:00p.m

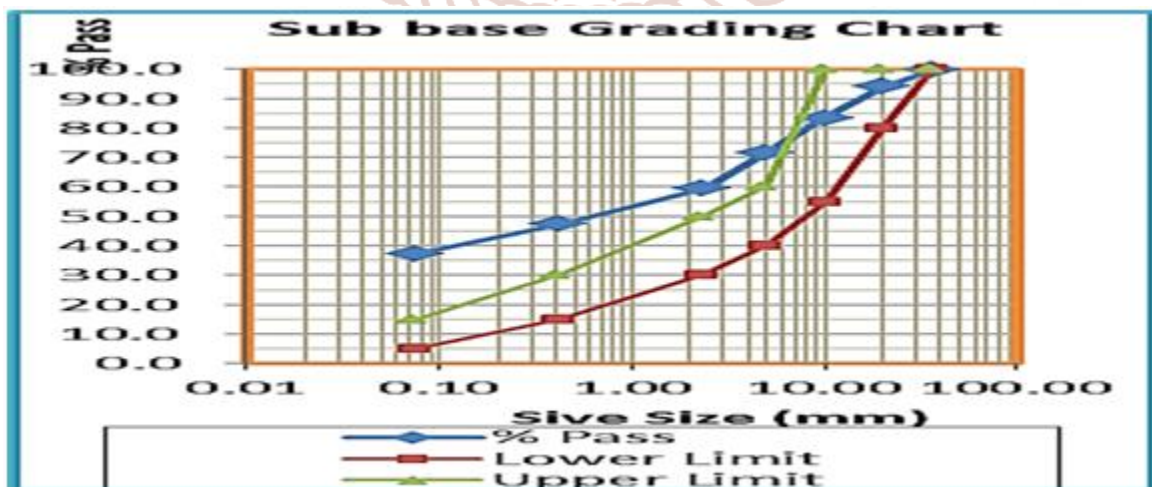
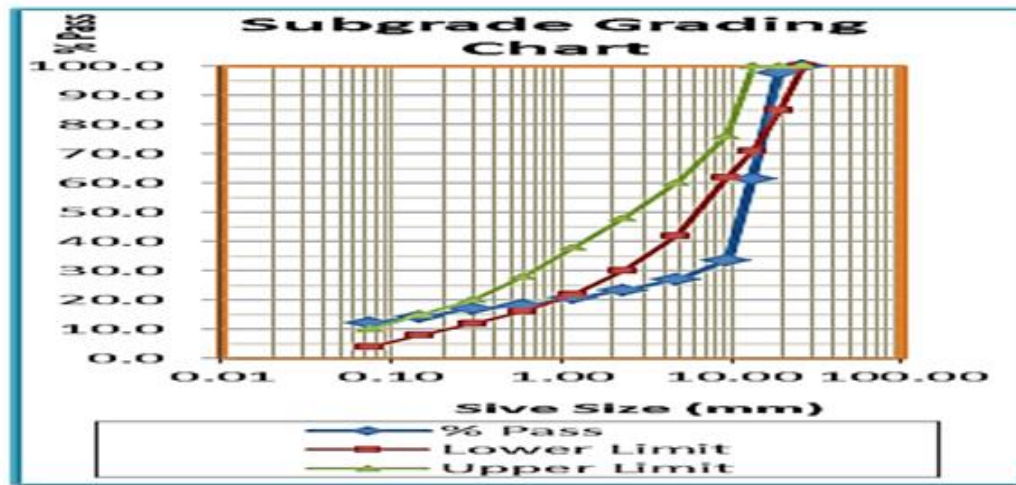
Fig 8: Laboratory test result for the grain size analysis of sub base

Figure 8 depicts that laboratory test result for the grain size analysis of sub base. At all sample stations, it is out of minimum and maximum limit of AASHTO T-11 Standard specification (the material passing 0.075mm sieve size by sieve analysis method) which implies not uniformly graded (poor graded). It was observed that the gradation of the sub-grade and the sub-base materials was not within the recommended range (out of the range).
