# Study on Distress Patterns, Causes and Maintenance of Flexible Pavement for Selected Portions

This paper presents the study on flexible pavement distresses and repair techniques in two selected road portions. It is very important to know the flexible pavement distresses and its patterns. Pavement deterioration is serious problem for road and traffic highway sector in Myanmar. Tada U-Airport road (6/0 to 8/0 mile) and Paleik-Tada U road (0/0 to 7/0 mile) portions are chosen in this study. The failure patterns are classified depending upon the visual investigation along the study areas and identify the failure patterns of the two selected road portions. Map cracking, depression, corrugation, rutting, longitudinal cracking, pothole, edge failure, crocodile cracking, delamination, raveling and bleeding are found in the selected road portions. Along the selected portions, the pavements are damaged by the effects of weather, organic growth, traffic wear and damages as well as deterioration due to aging, excessive traffic loading of heavy trucks, insufficient pavement thickness, material failure, design faults and construction faults. The required overlay thickness is calculated by usi

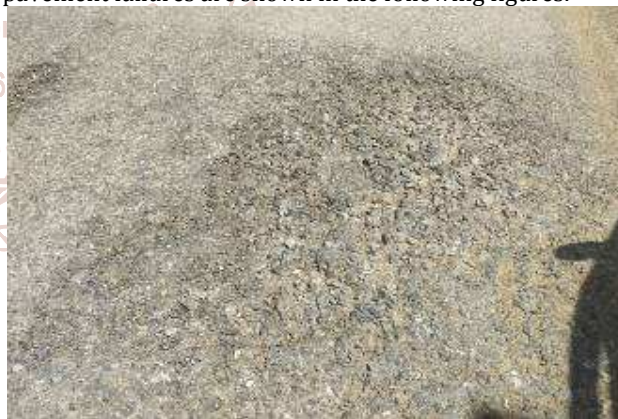
Figure3. Localized Raveling in Tada U Airport Road

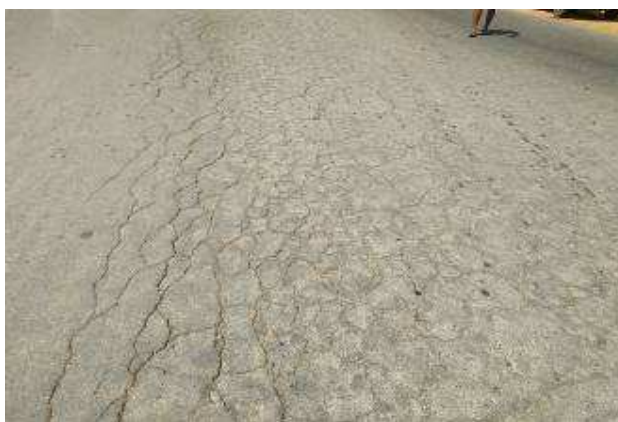
Figure4. Localized Map Cracking in Tada U Airport Road

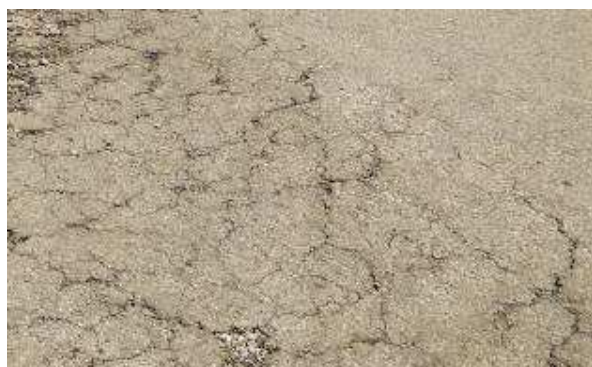
Figure5. Localized Crocodile Cracking in Tada UAirport Road

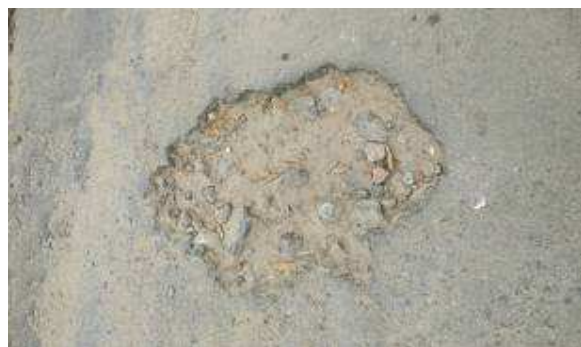
Figure6. Localized Pothole in Tada UAirport Road

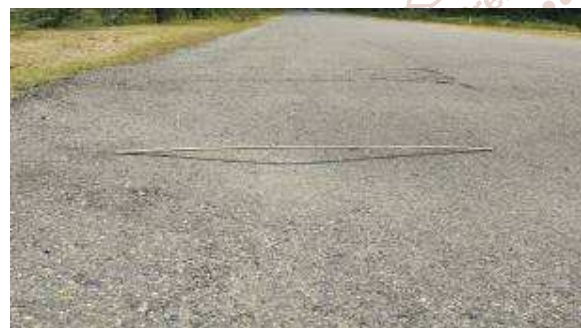
Figure7. Localized Depression in Tada UAirport Road

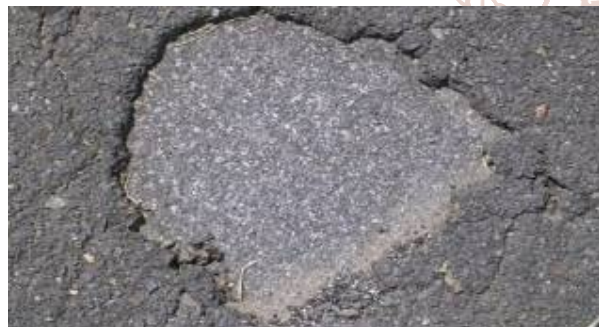
Figure8. Localized Delamination in Tada UAirport Road

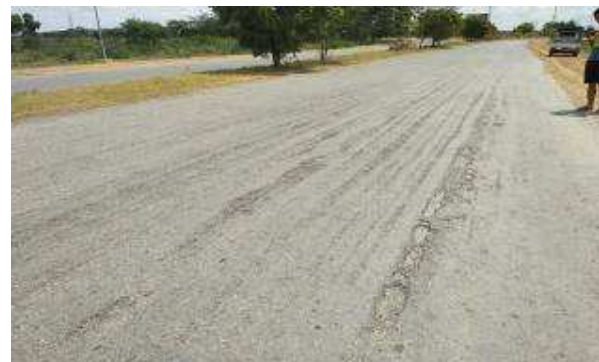
Figure9. Localized Rutting in Tada UAirport Road

The most failure pattern is rutting in Tada U-Airport road. These failures are continuous and terrible condition. And then, the failure area is large. So, this road maintenance is

not enough seal coat, need to maintain overlay method. According to Transport and Road Research Laboratory (TRRL), total deflection is exceed the allowable value of  $32 \times 10^2$  mm, the overlay maintenance is required for Tada U-Airport Road. The various stresses and strains of road layers are calculated by using Method of Three Layered System. So, the required overlay thickness is calculated by India Road Congress. In Tada U-Airport road portion, total thickness of existing pavement is 10 inches and the required overlay thickness is 6 inches after calculated.

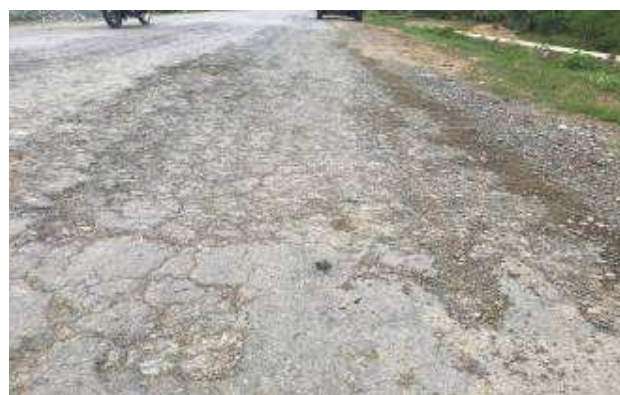
Figure11. Localized Raveling in PaleikTada U Road

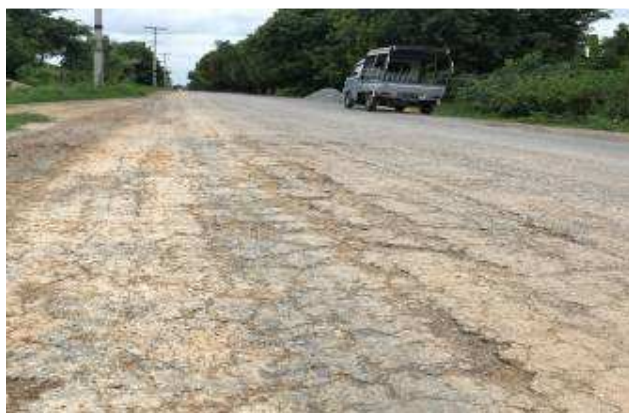
Figure12. Localized Map Cracking in PaleikTada U Road

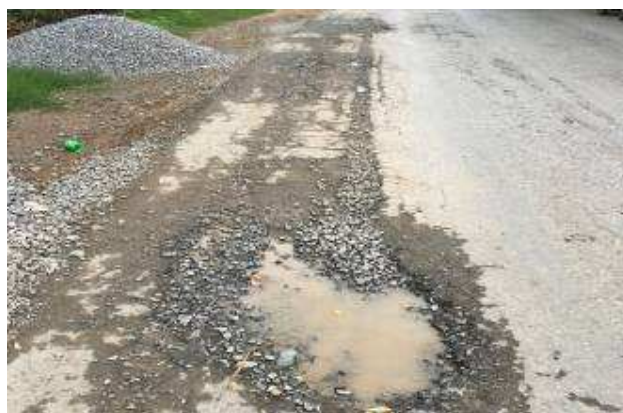
Figure15. Localized Pothole in PaleikTada U Road

The most failure pattern is pothole in PaleikTada U road. The road is used two ways and the extended each one way width is not enough to travel two vehicles as parallel. These failures are continuous and terrible condition. And then, the failure area is large. So, this road maintenance is not enough seal coat, need to maintain overlay method. According to Transport and Road Research Laboratory (TRRL), total deflection is exceed the allowable value of  $32 \times 10^2$  mm, the overlay maintenance is required for PaleikTada U Road. So, the required overlay thickness is calculated by India Road

Congress. In PaleikTada U road portion, total thickness of existing pavement is 8 inches and the required overlay thickness is 5 inches.

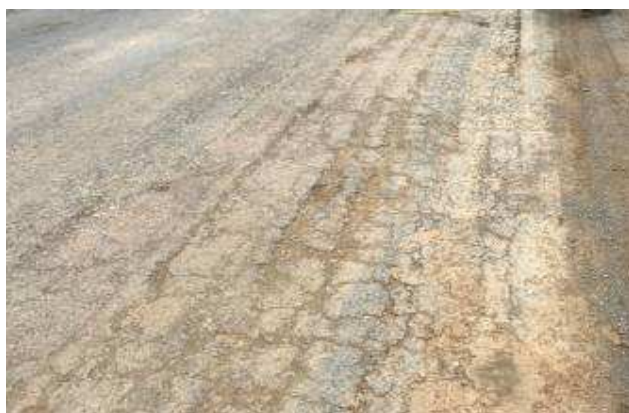
Figure13. Localized Crocodile Cracking in PaleikTada U Road

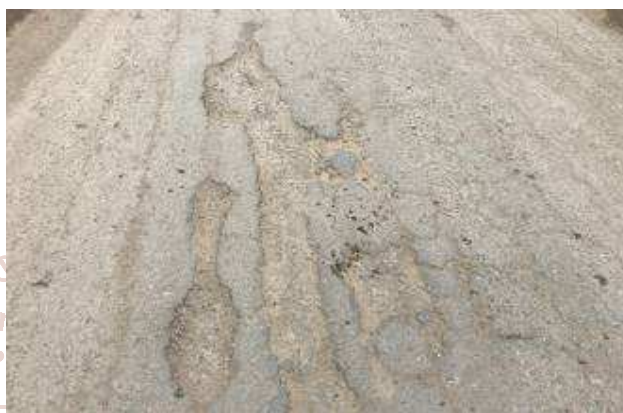
Figure16. Localized Delamination in PaleikTada U Road

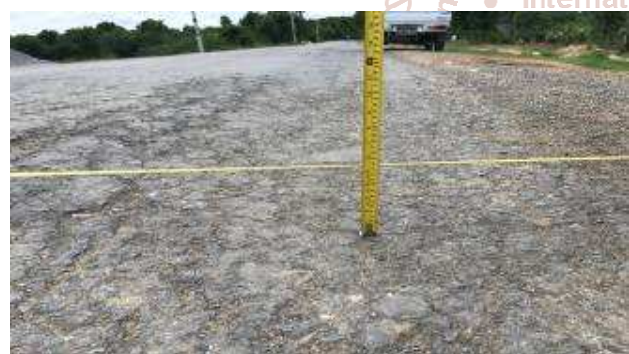
Figure14. Localized Depression in PaleikTada U Road

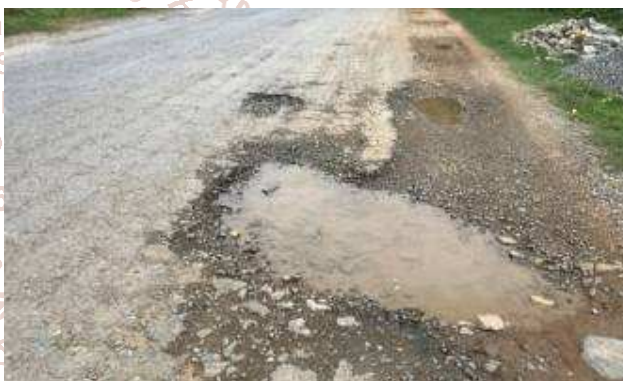
Figure17. Localized Edge Failure in PaleikTada U Road
