Investigation on the Existing Geometry of Pathein Suspension Bridge

Win Bo, Khin Maung Zaw, Kyaw Kyaw

ABSTRACT

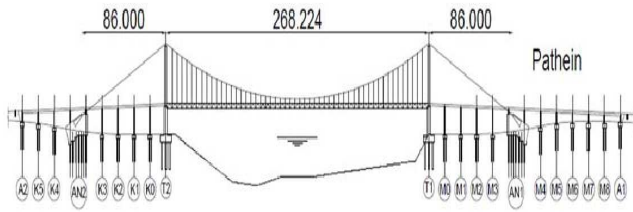
Fig. 1.a Elevation of Pathein Suspension Bridge

Pathein Bridge is a suspension bridge with a main span of 268.2240 m and the distance between the splay saddle in the anchor and main tower is 86.00 m as shown in Fig. 1. The carriage way consists of two lanes for motorized traffic on the decking of the truss, total width 8.5 m. the headroom for navigation is 33 ft and the deck has a transverse inclination of 0.5 % and longitudinal inclination of 1.0 %. It is designed with the following loadings;

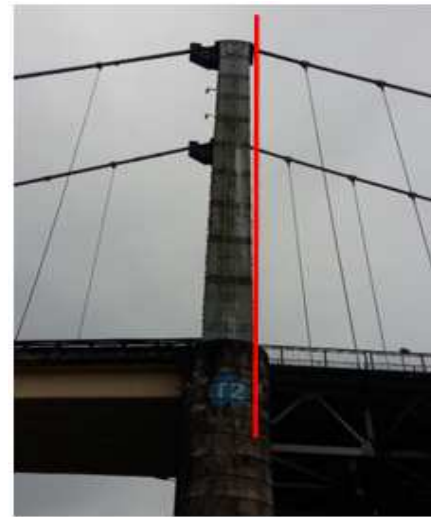
Fig. 2 Inclined tower

The main cables are suspended between two main towers. There may be many reasons tilting the top of tower towards river. As described before, because the region has soft alluvial ground, the horizontal force of the main cable may move concrete blocks and/or the tower foundation may rotate due to differential settlement. Moreover, it is due to some construction errors or the backstay cables lengths are longer than the optimum. Most hangers are inclined towards Pathein side and the towers top tilting amounts are not same. We can see clearly loss of camber and the unsymmetrical deflection of the main truss of this bridge.

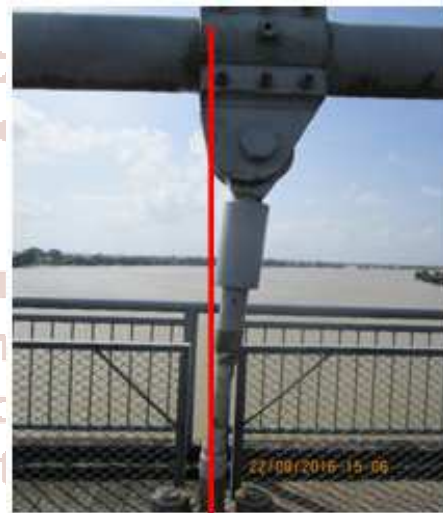
Fig. 3 Inclined hanger

The hangers are parallel wire strand type. There is one suspender per suspending point at 5 m apart. The suspenders are designed with high tensile strength galvanized steel wires. There are 61 numbers of 5 mm diameter strand wire for one hanger. Pathein suspension bridge was inspected in 2010 and 2011 with JAPAN-Myanmar Bridge engineer. It was reported some hangers are inclined and most of them are inclined towards Pathein side. But few hangers are towards Chaungthar side. The reason of these hanger inclination problem was not reported.

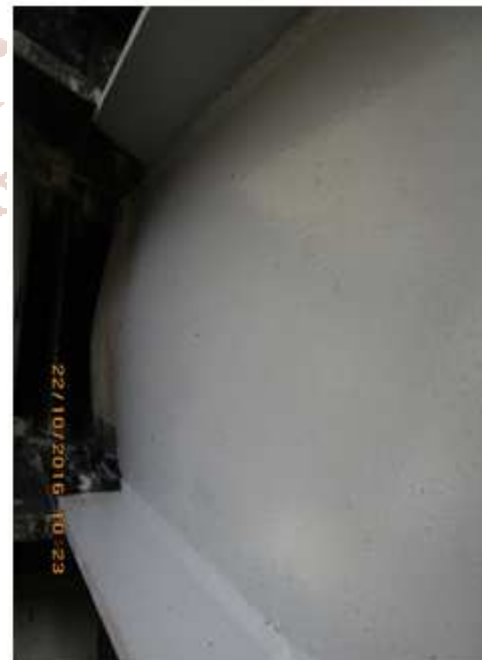
Fig. 4 Web crippling of Vertical member at downstream bearing of Chaungthar Side

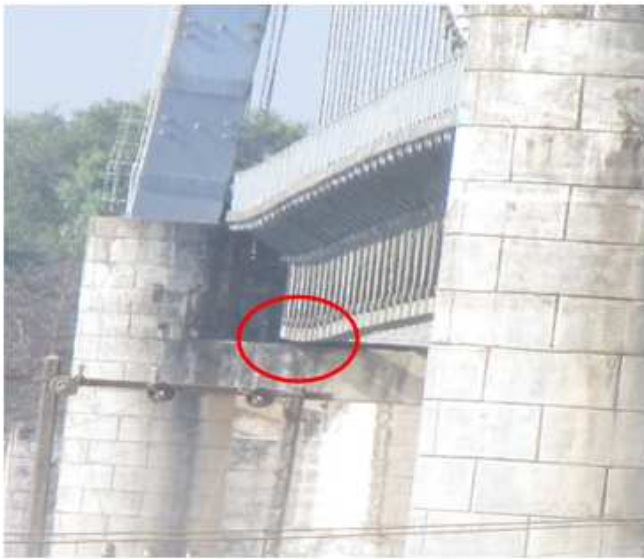
Fig. 5 Deflection of truss near Tower

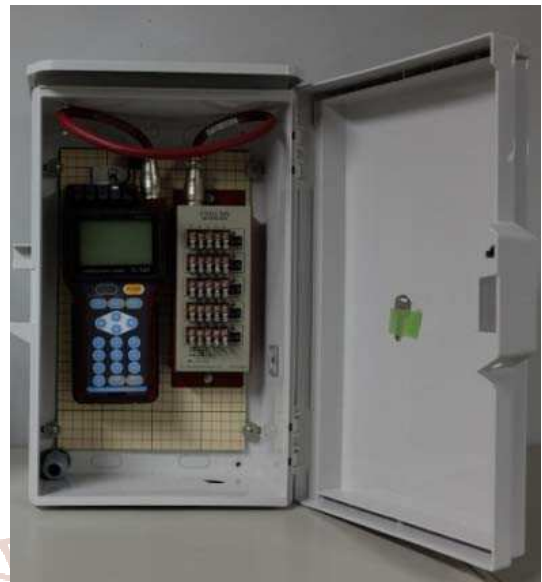
Fig. 7 Portable data logger

The main purpose of installing the monitoring system is to check whether the top of tower tilting is dead or alive. In order to monitor the inclination of the main tower, the system has an inclinometer and a portable data logger. The inclinometer is to measure the movement of tower and the data logger is to record the measured data of inclinometer. The monitoring system was installed both downstream towers of Pathein suspension bridge. Fig. 8 shows the plan view of the bridge site and the location of monitoring system. The tower movement which is positive or negative direction is also shown.

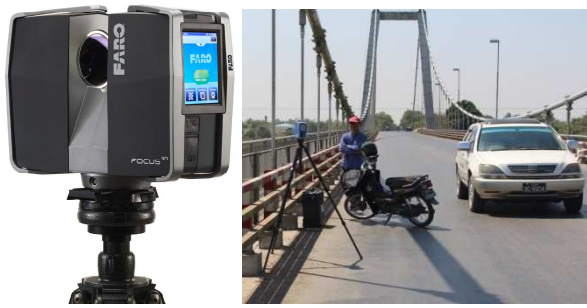
FARO 3D Laser Scanner is used for detailed measurement of Pathein Suspension bridge. It can produce incredibly detailed three-dimensional images of complex environments and large scale geometries. The resulting image is an assembly of millions of 3D measurement points that provide an exact digital reproduction of existing conditions. The measurements of using FARO 3D Laser Scanner to measure the detail measurements are described the following chart.

Fig. 9 FARO 3D Laser Scanner and Scanning Objects

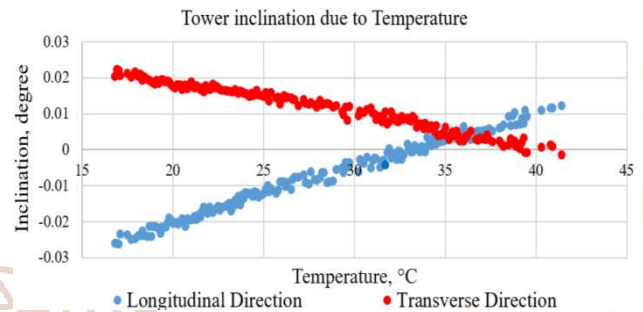
Fig. 10 Tower inclination at Chaungthar side due to temperature

Fig 10 and Fig 11 are the monitoring results for downstream tower of Chaungthar side from November 2017 to April 2018. Fig 10 shows the inclination degree of tower due to temperature fluctuation. The blue sports represent for the inclination degree parallel to bridge axis direction and the red sports are for perpendicular to bridge axis direction. Fig 11 describes the hourly recorded data of temperature, inclination degree parallel to bridge axis direction and perpendicular to bridge axis direction.

According to these recorded data, no significant amount of tower inclination degree can be seen. The inclination degrees are very small and these are due to the effect of temperature fluctuation. So we can conclude that the tower is stable or it is not alive.

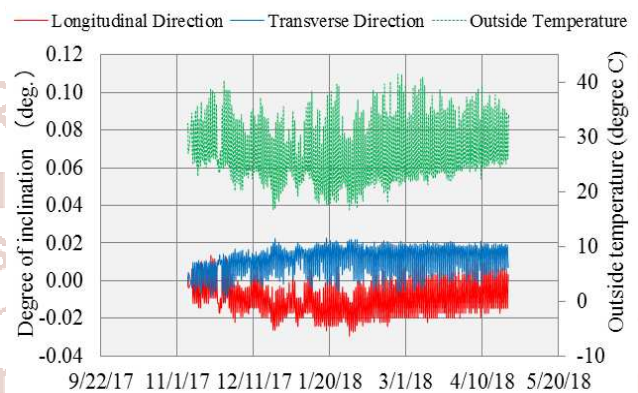
Fig. 11 Tower inclination and Temperature at Chaungthar side

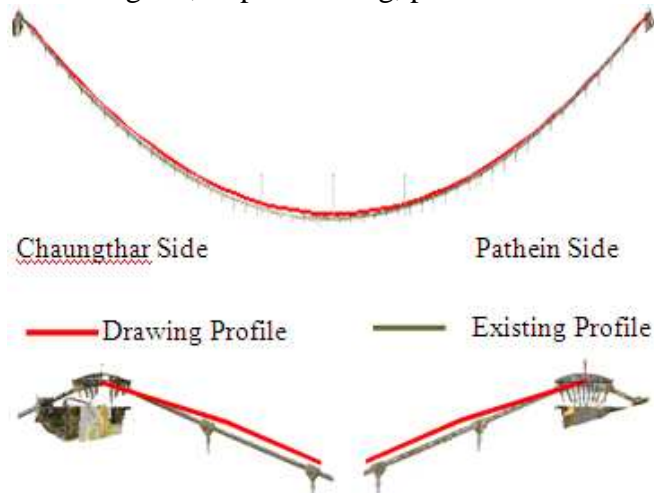
As describe the previous section, each tower has its own tilting amount. Because of this differential tilting, the existing main cables profile is unsymmetrical. Moreover these two main cables profile are different from its original, as per drawing, profile.

Fig. 12 Main Cable Profiles

Fig. 12 shows the two main cables profile, the existing main cable profile and profile as per drawing. The existing profile is lower than as per drawing profile. Table III describes the maximum sag of main cables profile and the difference of these two profiles. From Table II, it can be clearly seen that the downstream towers are more inclined than the upstream. This is the reason why the downstream main cable sag is lower than the upper one.

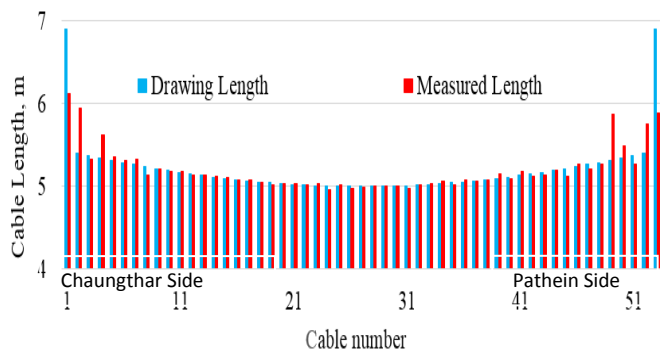
Fig. 13.a Upstream Cable length

The measured main cables length and as per drawing main cables length are shown in Fig. 13.a and Fig. 13.b. Fig. 13.a is for the upstream main cable length and Fig. 13.b is for downstream. The main cables difference near towers are noticeable and others are nearly the same length. The maximum segment length difference is 1.009 m at the nearest segment of Pathein side tower for upstream and 0.937 m at the nearest segment of Chaungthar side tower for downstream. The total upstream main cable length between the towers is 276.94 m and the downstream is 275.981 m. The length difference is 0.06% for upstream and 0.044% for downstream. Both upstream and downstream main cable lengths are shown in Table 4.

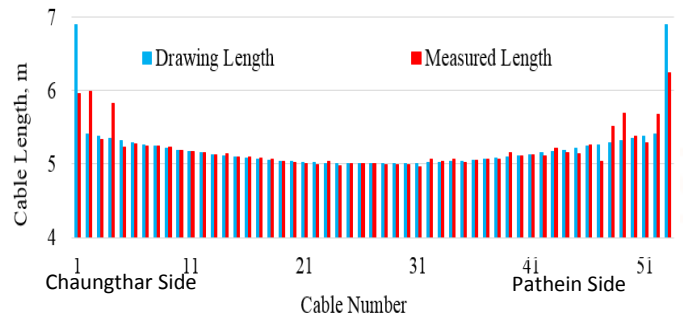
Fig. 13.b Downstream Cable length

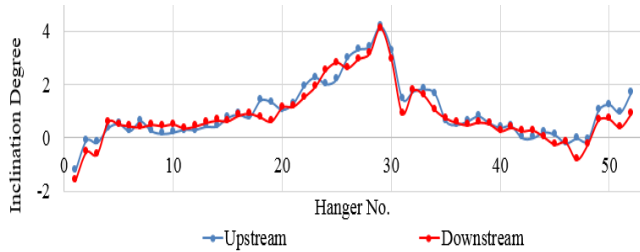
Fig. 14.a Hanger inclination measured with FARO 3D Laser Scanner

Fig. 14.a and Fig 14.b show the hanger inclination degree of Pathein suspension bridge. Fig. 14.a is the

measured results used FARO 3D laser scanner. The direct measured results used the electronic spirit level is shown in Fig. 14.b. From these two figures, the hangers near tower and the middle hangers are more inclined than others. Negative sign means the hangers are inclined towards Chaungthar side. The towers at Chaungthar side are more inclined than the tower at Pathein side. This is one of the reasons why the most hangers are inclined towards Pathein side. Fig. 14.c is the hanger inclination degree measured with FARO 3D Laser Scanner and electronic spirit level. Although the measured results are different, their lines shape are similar. Fig. 14 d. is the hanger length difference between the measured length and as per drawing length. All existing hangers are longer than as per drawing length. This may be one of the factors that this suspension bridge steel truss vertical profile has unusual deformed shape. The blue line represents upstream hangers' length difference and the red line is for downstream.

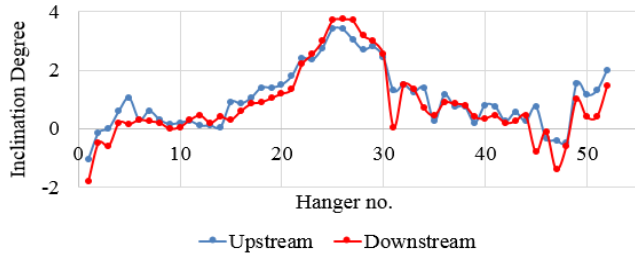
Fig. 14.b Hanger inclination measured with electronic spirit level

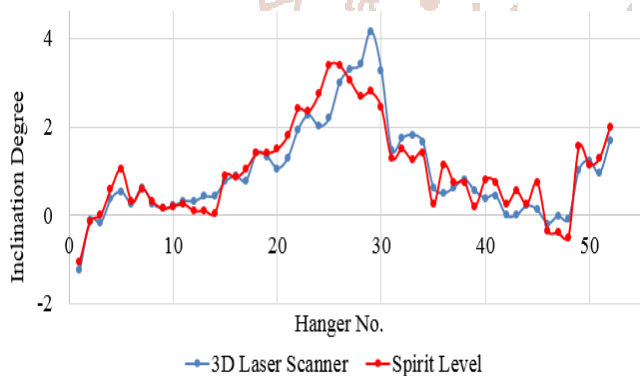
Fig. 14.c Hanger inclination measured with FARO 3D Laser Scanner and electronic spirit level

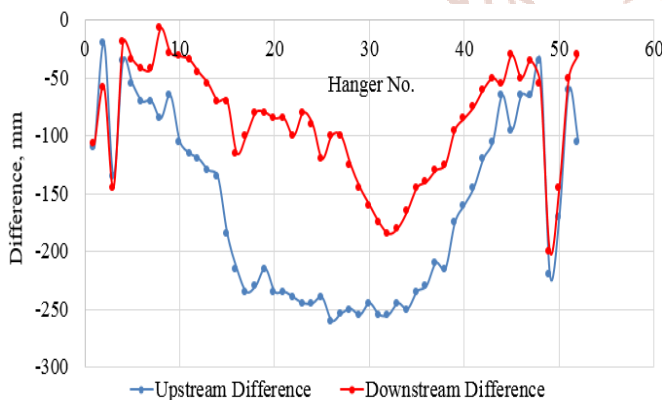
Fig. 14.d Hanger length difference

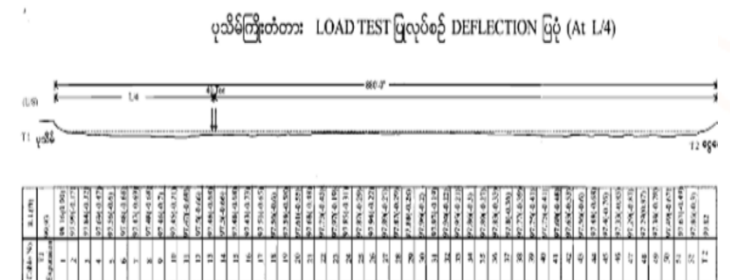
Ministry of Construction have checked regularly to know the condition of this bridge especially the inclination of towers and the vertical profile of steel stiffening truss. Moreover variations of the vertical profile were recorded during a load test program tested in June 2016. It was done with two dump trucks weighing 20 tons each and the total weight is 40 tons. The trucks were placed at three locations on the bridge and Fig. 15 is one of the locations of trucks during load test program.

Fig. 15 Location of trucks during load test at L/4 Span

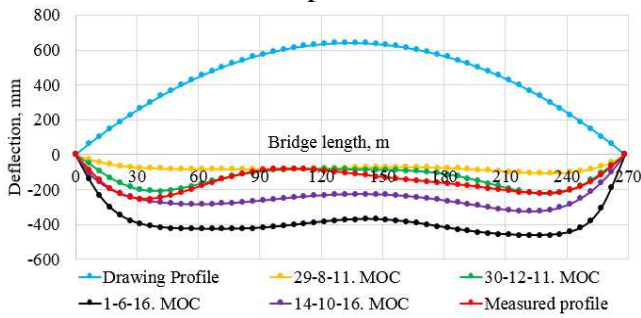
Fig. 16 Deflection of Patheingyi suspension Bridge

Fig. 16 shows the vertical profile of steel stiffening truss of Patheingyi suspension bridge. The blue line is as per drawing profile of the truss and the maximum camber is + 642.15 mm at the mid-span of bridge. The construction was completed in 2004. The yellow colour line is the truss profile measured by ministry of construction survey team in September 2011. At that time, the road surface was under the horizontal line. The maximum deflection is -104.233 mm and that point is 33 m from Patheingyi side tower. Meanwhile the mid-span deflection was -74.305 mm. at the end of year 2011 measurement, the maximum deflection became - 224.334 mm and mid-span deflection was - 84.683 mm. The deflection was gradually increased and it was found the worst condition in July 2016 measurement. But in October 2016 measurement, recovery deflection was occurred. The red line is the deflection measured with FARO 3D laser scanner in April 2017. According to that measurement, the maximum is -253.49 mm near Chaungthar side tower and mid-span deflection is -109.85 mm.

Based on these investigation results, although the inclinations of towers are different, both downstream towers tilting are more than the upstream one. Moreover, both towers at Chaungthar side are more inclined than Patheingyi side. This is the reason why the downstream main cable sag is greater than the upstream one and most of hangers are inclined towards Patheingyi side. The maximum hanger inclination is 4.16 degrees and it is occurred at mid-span. The existing truss deformation is unusual pattern and it may be due to the differential inclination of tower. Measuring the existing geometry is one of the essential processes to model and analyze the structures. The existing structural performance of this bridge can be assessed using these investigative data. After assessing the existing structural performances, the required action plan can be proposed confidentially.
