# Durability Assessment of Corrosion-Resistant Reinforcement Materials in Marine Structures

Sunil Kumar<sup>1</sup>, Er. Rajbala, (Guide)<sup>2</sup>

## ABSTRACT

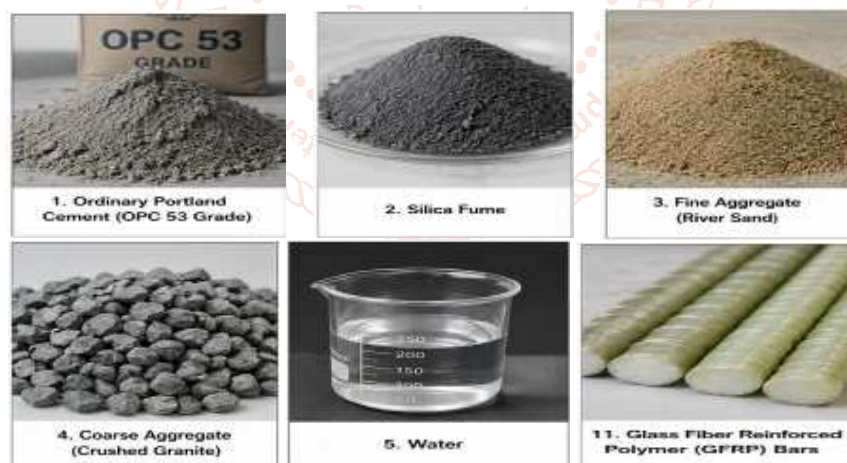
Figure 2: Material Used

GFRP bars consist of high strength glass fibres in a thermosetting polymer matrix. They have high corrosion resistance, chemical resistance and electromagnetic interference resistance, and can be used in marine structures where the steel reinforcement is prone to rapid corrosion.

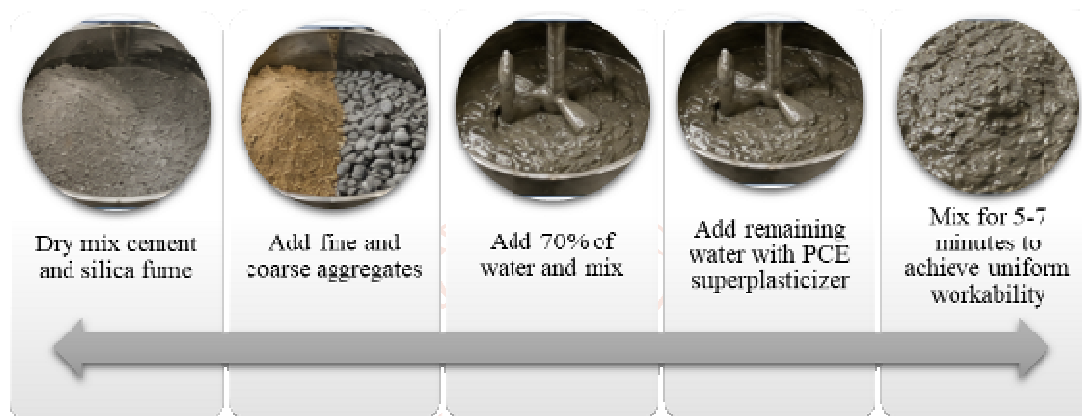
**Figure 3: Mixing process**

All materials are accurately weighed and checked for compliance with relevant standards before mixing. Cement and silica fume are first mixed dry to achieve uniformity of dispersion. The fine and coarse aggregates are placed in a pan mixer and then the blended binder materials are added. About 70% of the water required for the mix is delivered at start and the remaining water containing the dissolved superplasticizer is pumped in as a graded addition to achieve a “homogeneous and workable concrete mix”. The mixing is continued until a uniform consistency is obtained, which will take about 5-7 minutes. Before casting, the properties of fresh concrete (slump, fresh density, and air content) are measured to verify that the concrete would meet the performance requirement.

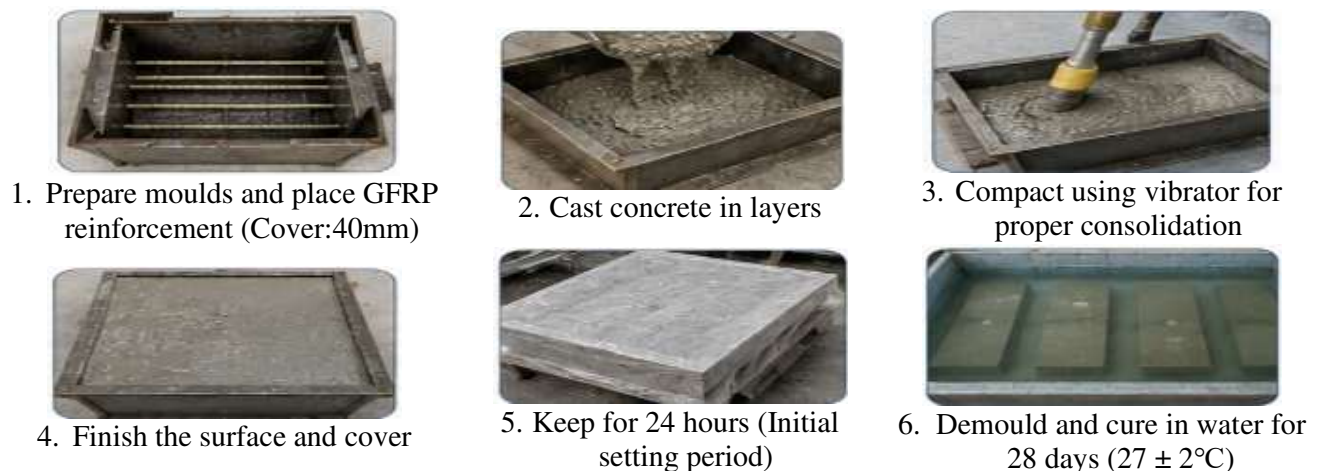
**Figure 4: Specimen preparation**

The various geometries of specimens are created to assess the mechanical, durability, and structural behavior of GFRP-reinforced concrete under simulated marine environments. The compressive strength is measured using cubes, the split tensile strength and modulus of elasticity is measured using a cylinder, flexural strength is measured using prisms, structural behavior and crack propagation is measured using reinforced beams, and long-term chloride exposure and durability is measured using reinforced slab panels.
