Geotechnical Investigation of upper Keng Tawng Dam

Man Deih Cing, Hla Myat Htwe

West Yangon Technological University, Yangon, Myanmar

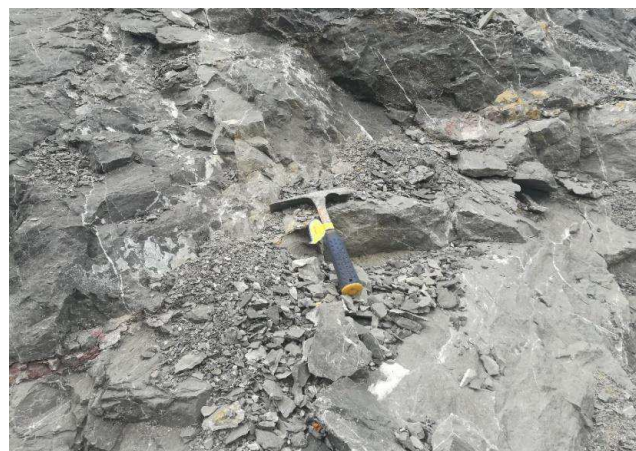
Figure (2) Natteik Limestone at Quarry Site

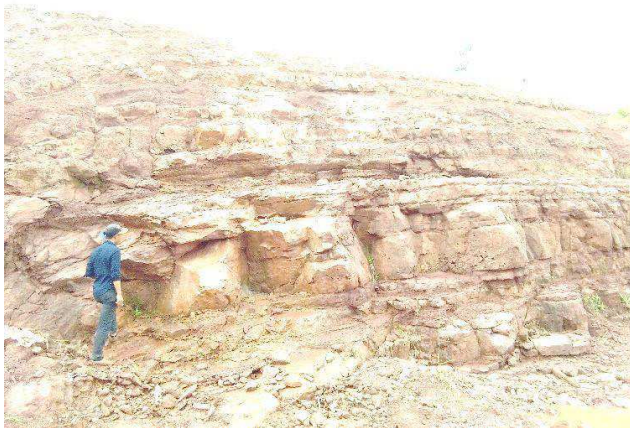
Figure (3) Kalaw Red Bed at left abutment

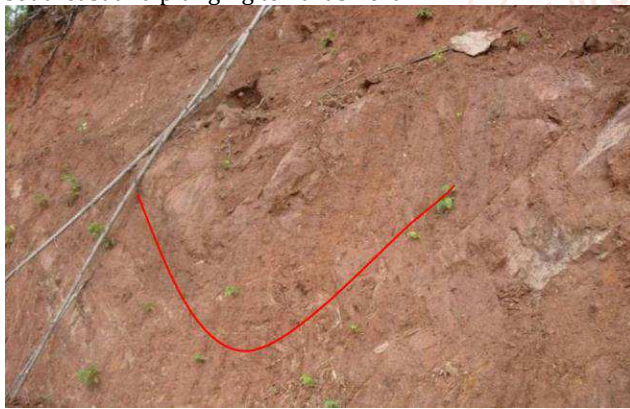
Figure (4) Synclinal fold structure observed at downstream of right bank.

The major fold is seen between the Kalaw Red Bed of conglomerate and sandstone. The fold, anticline, occurred within the three formations of plateau limestone, Natteik Formation and Loi-an series. The syncline is formed in the Kalaw Red Bed. The synclinal axis is trending northwest-southeast and plunging towards north.

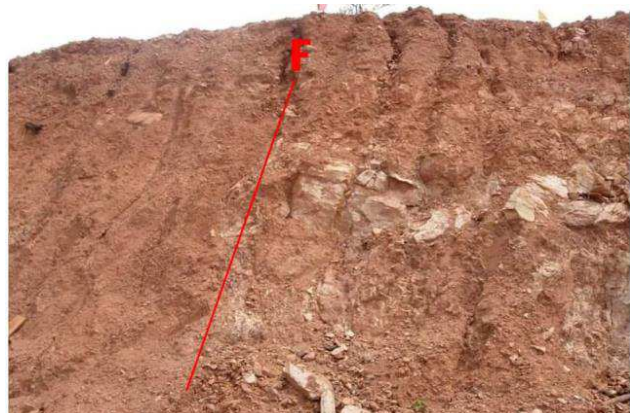
Figure (5) Fault observed at bench slope of the left bank.

There are ten photo-lineaments (probable weak zones) showing in the regional geological map. These lineaments are trending nearly N-S, NW-SE and NE-SW in direction. In westernmost part of the map area, one of lineaments is occurred along a series of sink-holes of Plateau Limestone as a clear evidence of weak zone.

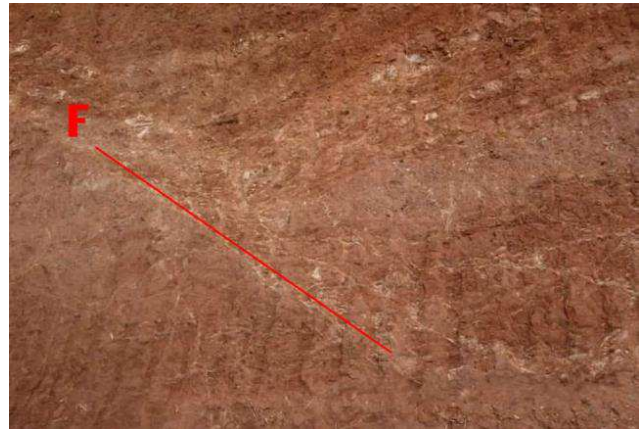
Figure (6) Fault observed at the road cut of the right bank.

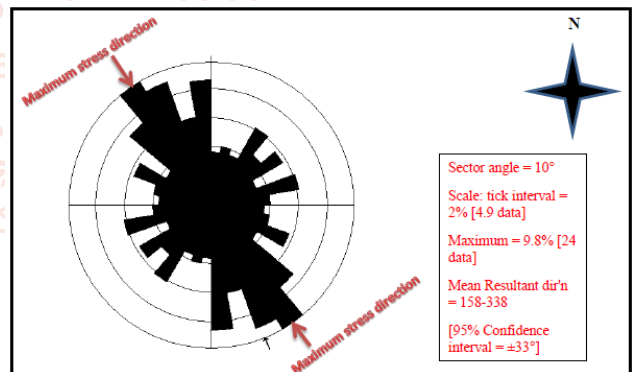
Figure (7) Joints rose diagram of the study area.

These joints were plotted on a joint rose diagram three sets of joints are observed; (1) longitudinal or strike joints, (2) cross or dip joints and (3) oblique or diagonal joints.

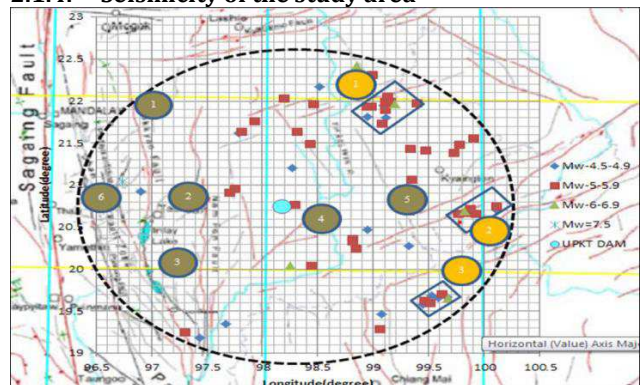
Figure (8) Seismic source zones within the faults of 200km of the project

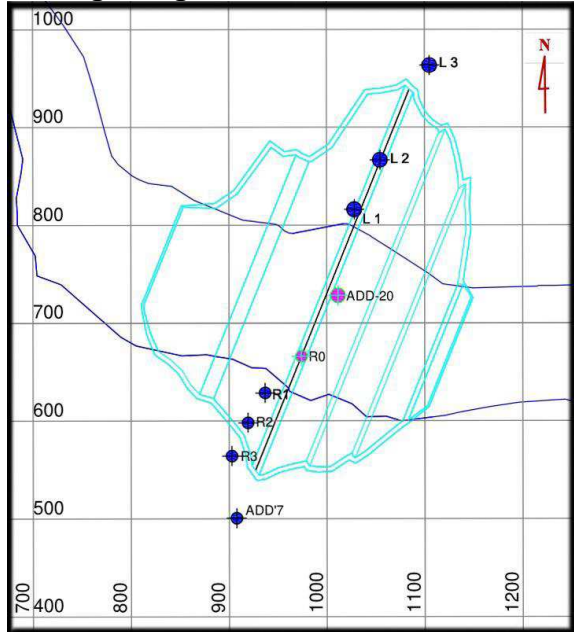
Figure (3.1.a) Main dam boreholes location plan map

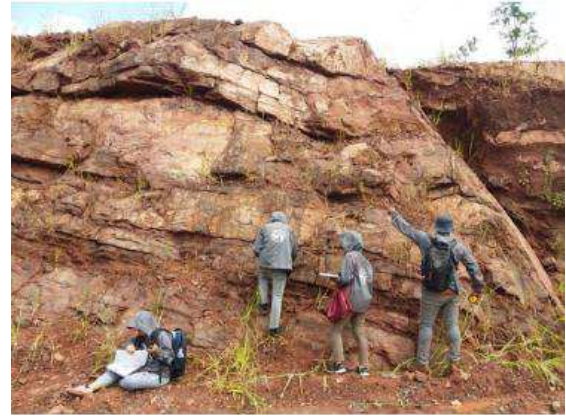
Figure (3.1.d) Studying photo at the left abutment of Upper Keng Tawng dam axis

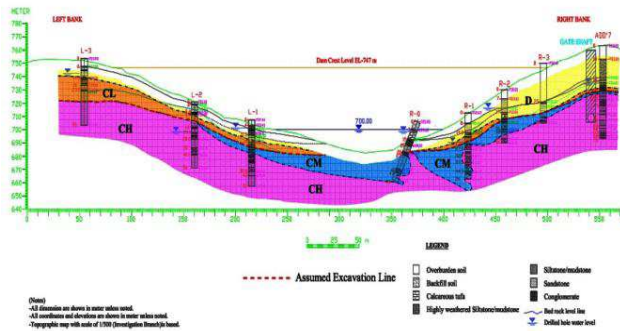
Figure (3.1.b) Foundation rock class along the Upper Keng Tawng dam axis

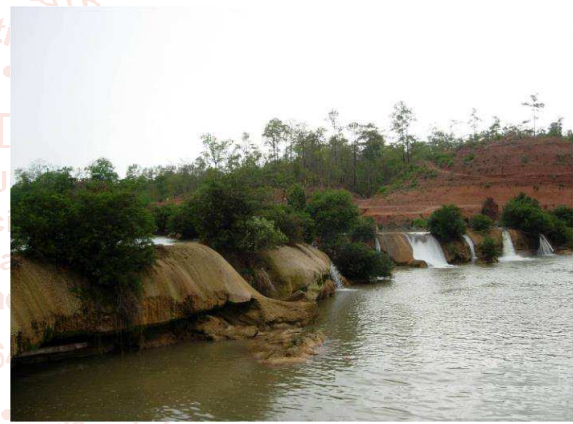
Figure (3.2) Calcareous tufa in river section of dam site

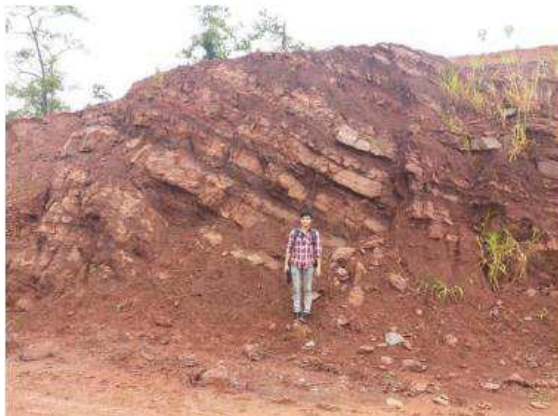
Figure (3.1.c) Outcrop photo near the left abutment of Upper Keng Tawng dam axis

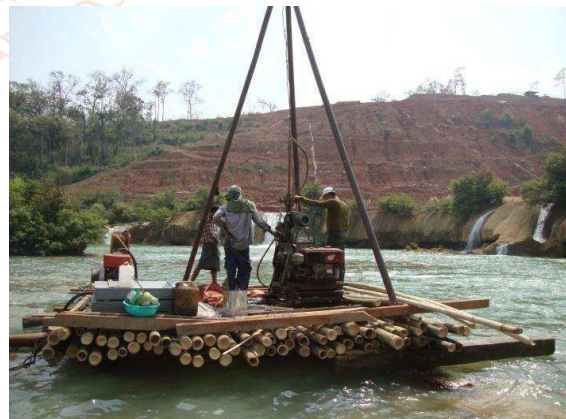
Figure (3.3) ADD 20 working photo at river section

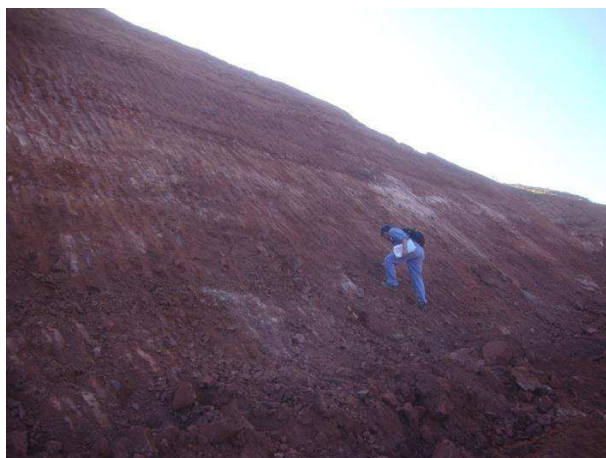
Figure (3.4.a) Slope cutting near the right abutment of Upper Keng Tawng dam axis

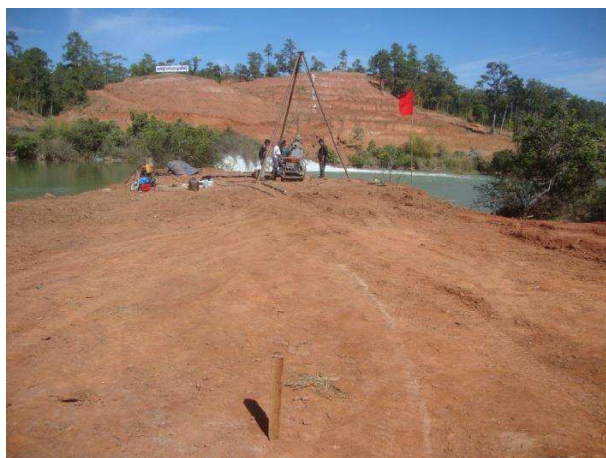
Figure (3.4.b) Diamond Core Drilling at right abutment of Upper Keng Tawng dam axis
