# Strength Assessment and Restoration of RC Structures by Structural Health Monitoring Techniques

A. Karthikeyan<sup>1</sup>, R. Manirasu<sup>2</sup>

<sup>1,2</sup>Mahendra Engineering College (Autonomous), Mallasamudram West, Namakkal, Tamil Nadu, India

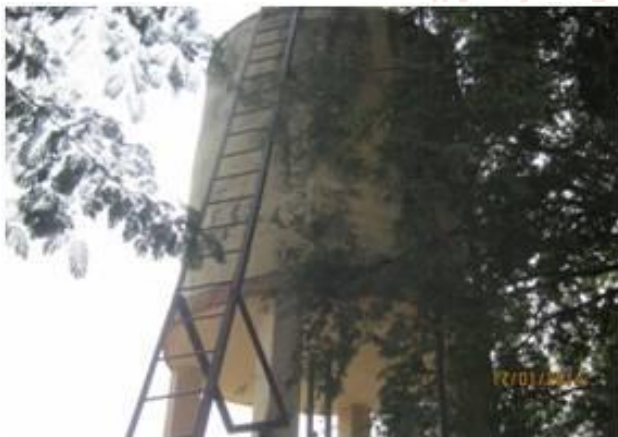
The Water tank was constructed in the year 1985. The capacity of Water tank was 15000 litres. The water tank is rested on four Columns, where columns are connected by Braces of size 250mmx250mm.

**Fig.3.1 Image of the Water Tank**

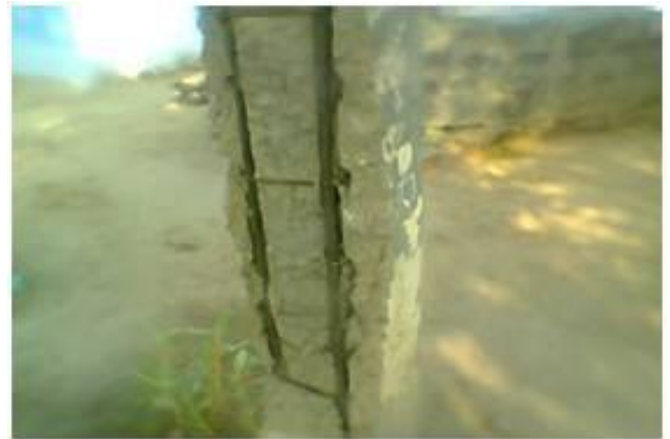
**Fig.3.2 Image of Spalled Column of the Water Tank**

Member	Point 1 (in mV)	Point 2 (in mV)	Point 3 (in mV)	Average (in mV)	Probability of Corrosion
Column 1	-460	-420	-397	-426	90%
Column 2	-405	-426	-415	-415	90%
Column 3	-396	-411	-387	-398	90%
Column 4	-368	-391	-361	-367	90%

After carrying out the NDT tests in the selected project areas we found that the water tank at Sunnambukarayur was in poor condition. Its structural members were corroded to 90% it becomes unfit for use, while the Ration shop building at Kenjanur and Staff quarters at Bhavanisagar are in good condition but some minor defects had been mitigated. The damages located in the Ration shop and staff quarters can be rectified by adopting suitable repairing techniques. The suitable repairing techniques for rectifying the minor damages in the structures had been suggested.

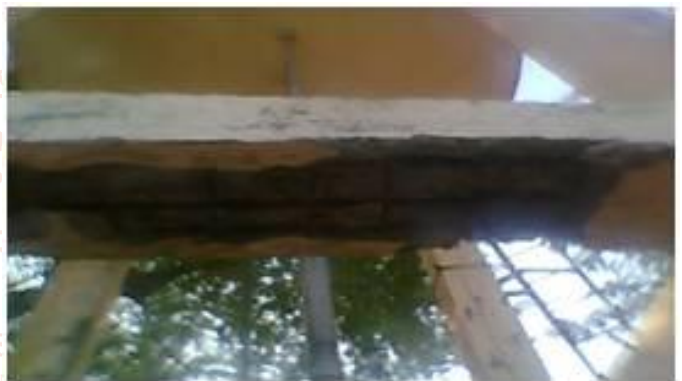
**Fig.3.3 Image of the Spalled Brace of the Water Tank**

Member	Point 1 (in mV)	Point 2 (in mV)	Average (in mV)	Probability of Corrosion
Brace 1	-370	-352	-361	90%
Brace 2	-341	-384	-363	90%
Brace 3	-297	-325	-311	Uncertain
Brace 4	-347	-381	-364	90%

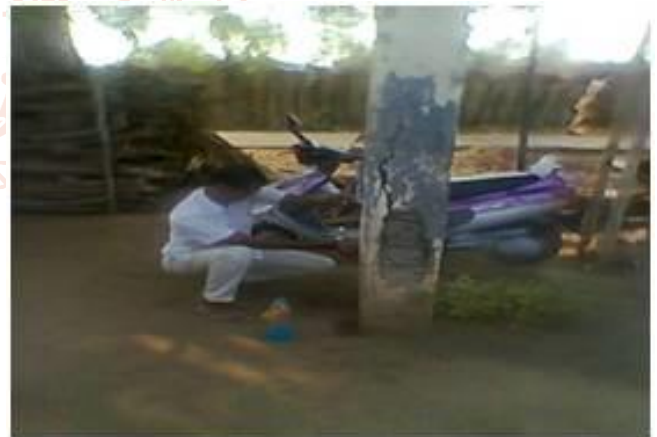
**Fig.3.4 Half Cell Potential Difference Test being conducted on Column of the Water Tank**

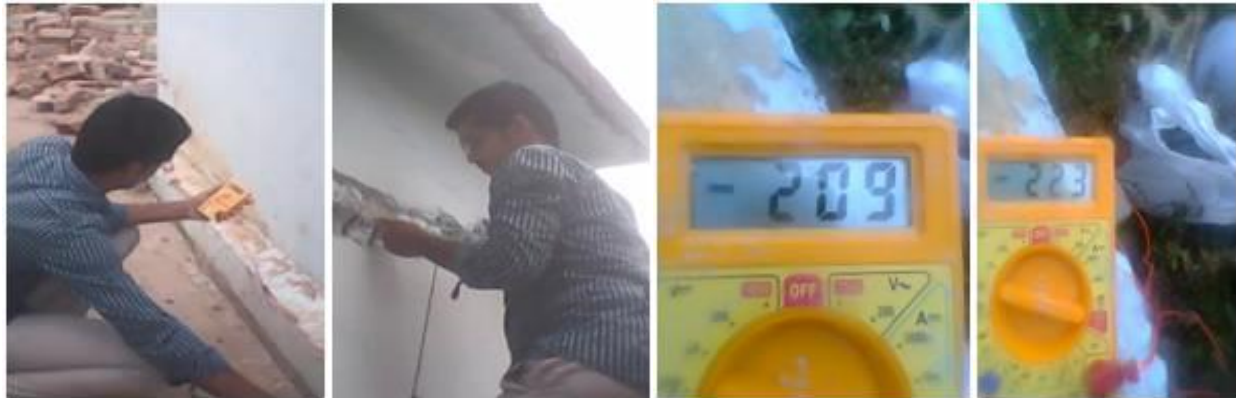
Fig 4.1 Half Cell Potential Difference test being conducted on the Ration Shop building

Member Plinth Beam	Half Cell potential Difference between Reinforcement and Concrete in mV
Point 1	-223
Point 2	-209
Point 3	-159
Point 4	-169
Point 5	-185
Point 6	-168
Point 7	-207
Point 8	-185
Point 9	-221
Average	-192

Member-Main Roof	Half Cell potential Difference between Reinforcement and Concrete in mV
Point 1	-271
Point 2	-307
Point 3	-289
Point 4	-321
Point 5	-332
Point 6	-296
Point 7	-281
Point 8	-312
Point 9	-290
Point 10	-312
Point 11	-261
Point 12	293
Average	-298
