Comparative Study of the Tribological Properties of the Swashplate Axial Piston Pump for Different Materials of the Valve Plate on Different Load Applications

ABSTRACT

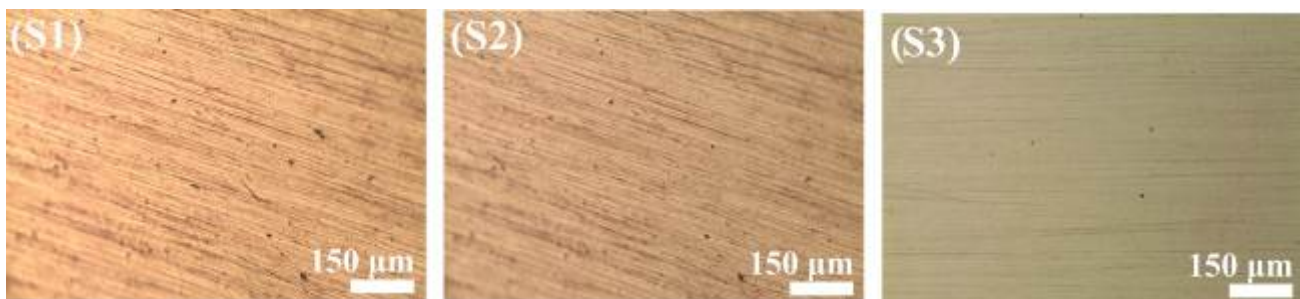
Fig. 3 surface topography of the specimens before the coefficient friction tests

The root means square (RMS) value was used to evaluate the surface roughness. The R_a values of the lower specimens were 0.4 μm. The specimens surface topography before coefficient of friction tests is shown in **Error! Reference source not found.**

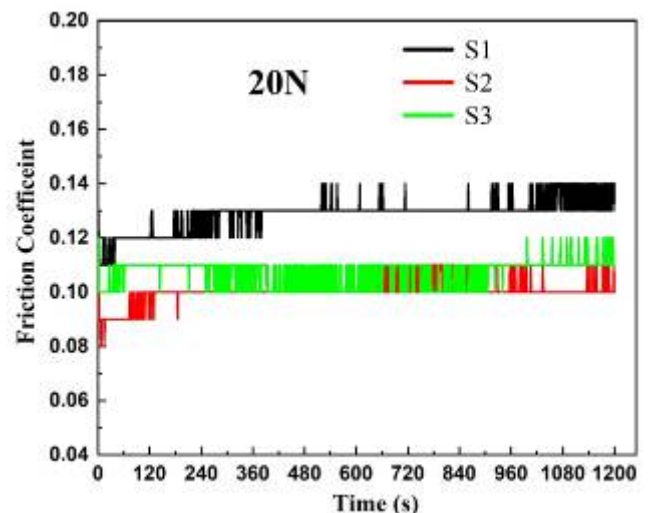
Fig. 4 Measured coefficient of friction during wet reciprocating sliding between B4 and the valve plate materials at a loading force of 20 N

The coefficient of friction (COF) results is summarized in Fig. 4-Fig. 7 for the upper specimen B4 brass sliding on the three lower specimens; S1, S2, and S3, performed under different loading of 20 N, 40 N, 60 N, and 80 N, respectively. When the loading force is large, the ball and the disc are in the sliding friction process, and the contact pressure increases; likewise, the lubrication oil keeps changing. Hence, the gap between the friction pairs varies. The lubrication state is changed from boundary lubrication to mixed lubrication and then to hydrodynamic lubrication since the surface of the specimens is not entirely smooth.

Moreover, from the COF results, most of the debris produced was flushed out of the contact surface, giving a stable coefficient of friction curves for all the applied loads due to the oil used for the lubrication of the interface. The coefficient of friction at 20 N for S1 is slightly higher ~ 0.14 than that of S2 and S2. Even though the difference is slight, the three specimens show very short instability running time due to the effect of the hydraulic oil, and the friction coefficient increased slowly and finally remained stable. The friction coefficient changed slightly with the normal load changing at a constant temperature (Fig. 4-Fig. 7).

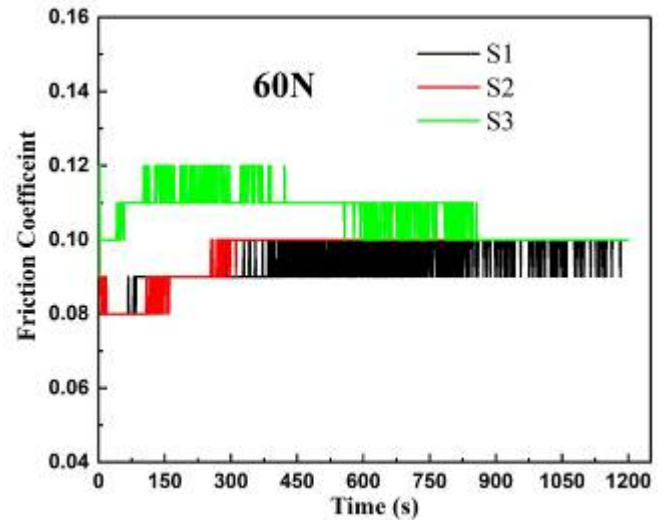
Fig. 6 Measured coefficient of friction during wet reciprocating sliding between B4 and the valve plate materials at a loading force of 60 N

Averagely, from the results of the tribological test shown in (Fig. 4-Fig. 7) for the various test conditions. S2 specimen coating exhibits the lowest coefficient of friction value, and the S1 specimen has the highest COF value. All specimens exhibited similar COF curves, which showed excellent friction-reducing abilities; meanwhile, the addition treated and material composition containing higher Pb element (Table 4) of S2 specimen surface coating showed the best anti-wear abilities.

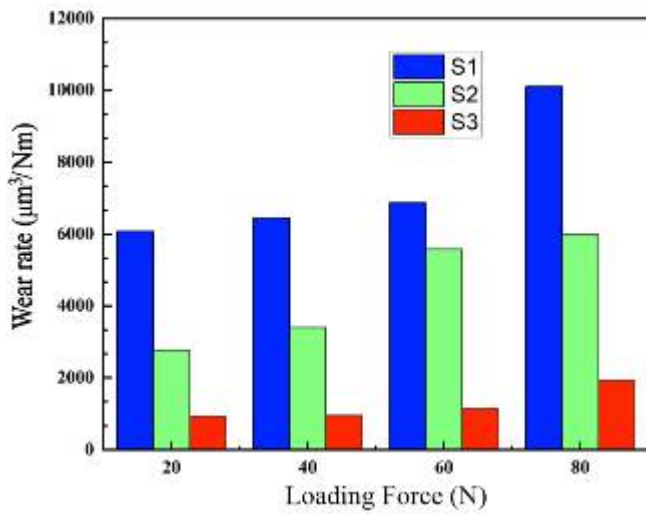
Fig. 8 Average wear rate results of lower specimens for different Loading force

Ideally, wear that occurs during sliding contact surface is usually considered a mechanical process. However, well-developed models of mechanical wear based on deformation and fracture have been reported [16]. compares the lower specimens' wear rate for the various loading forces applied at a constant temperature. The S3 specimen shows a minimal wear rate (Fig. 8); at the maximum loading force, the wear rate was ~ 1750 $\mu\text{m}^3/\text{Nm}$. In other words, the wear resistance of the S3 specimen surface has increased due to the strain hardening of the surface. Hence, it exhibits low wear volume loss and uniform increasing wear rate, rather than a continuous increase of larger volume lost as seen on the S1 and S2 specimens. The wear rates of the S1 specimens are much greater, particularly at 80 N (~10190 $\mu\text{m}^3/\text{Nm}$).

Fig. 10-Fig. 12 presents the 3D view and SEM images of friction tests generated on wear scar surfaces under different working conditions. The amount of wear debris observed was relatively limited because most debris was flushed out of the wear scar by the lubricating medium, reducing the abrasive wear. Even though ductile iron (S3) had the lowest wear rate (Fig.

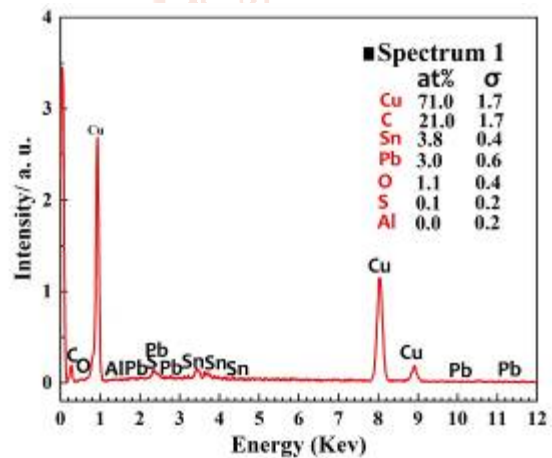
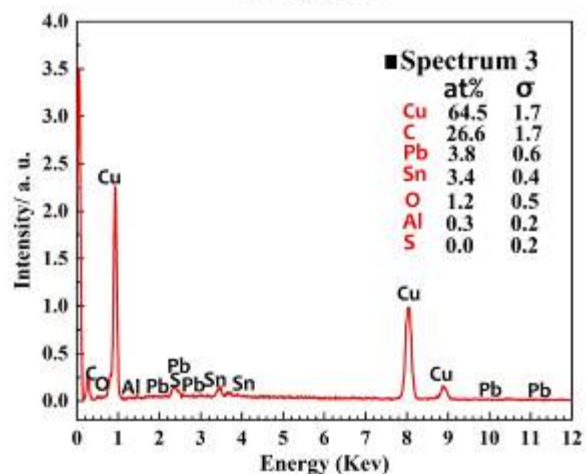
Fig. 13 Energy dispersive X-ray spectrometer (EDS) analysis results for the S1 specimen at 80 N load for three analysis positions with corresponding spectrums.

The SEM images depict the presence of small particles and some larger particles on the surfaces of the S1 coating. In contrast, S3 has fewer particles than the S2 specimen, with few particles on its surface. The EDS results shown in Fig. 13 further indicated signs of transfer of brass particles. In addition, the presence of Lead (Pb) elements enhances the wear resistance of the surface, the mass fraction of Cu was reduced as the contact pressure increased, and the S1 specimen showed more abrasive grooves at 80 N.

Furthermore, the upper specimen showed few amounts of bronze accumulating on the surface of the B4 due to the influence of the lubricating films and material hardness difference; the EDS analysis Fig. 13-Fig. 14 further confirmed it. Moreover, lead (Pb) elements detected on the surface of the S2 coating were very small for the area analyzed since lead elements are not uniformly distributed on the surface due to their dense nature. As exhibited in Fig. 13, spectrum 3 confirmed the mass fraction loss of Cu on the surface of the S1 specimen.

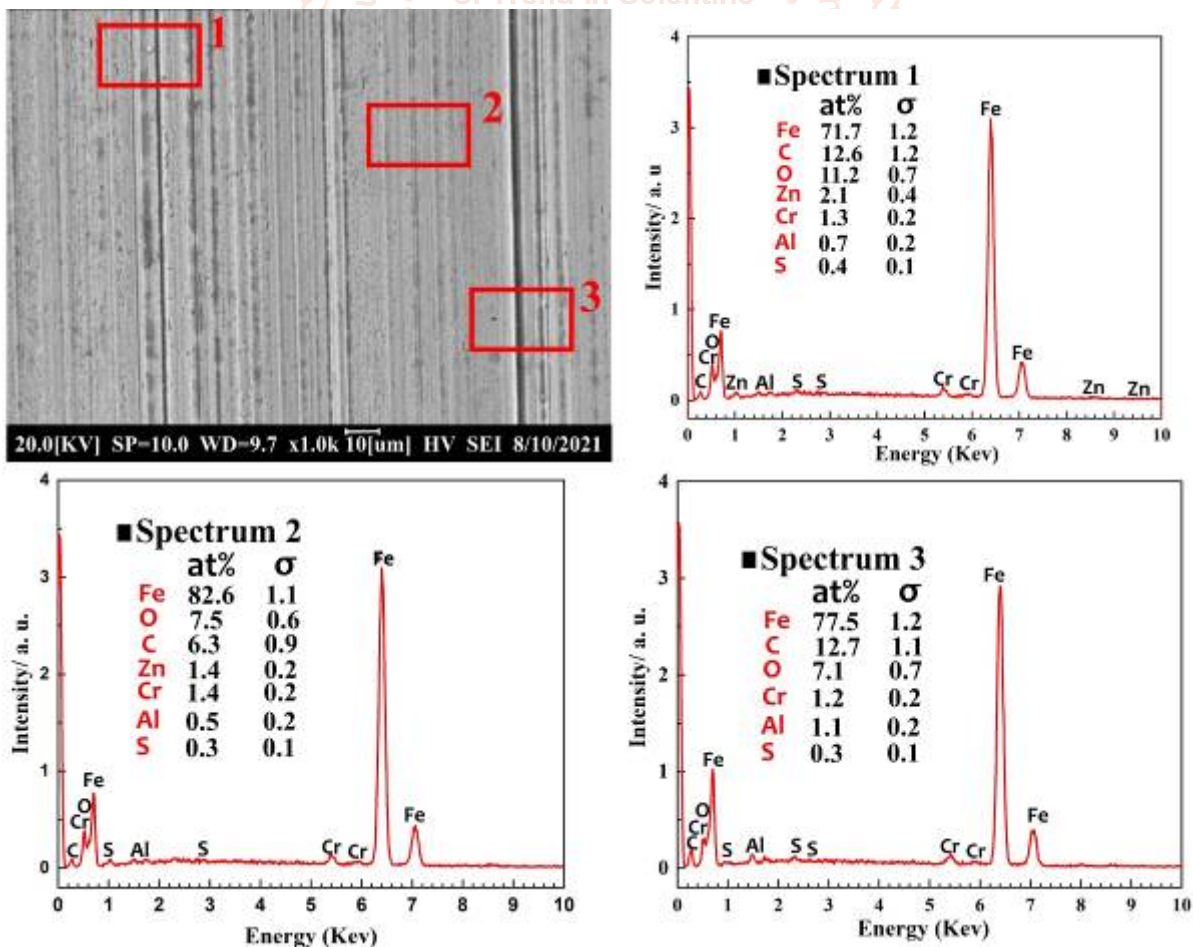
Fig. 15 Energy dispersive X-ray spectrometer (EDS) analysis results for the S3 specimen at 80 N load for three analysis positions with corresponding spectra.

The energy spectrums in Fig. 15 make it evident that the main component of the wear scar is still the original composition of the S2 specimen; there was no possibly material transfer. Even though there were few asperities on
