# Study on Distress Patterns, Causes and Maintenance of Flexible Pavement for Selected Portions

This paper presents the study on flexible pavement distresses and repair techniques in two selected road portions. It is very important to know the flexible pavement distresses and its patterns. Pavement deterioration is serious problem for road and traffic highway sector in Myanmar. Tada U-Airport road (6/0 to 8/0 mile) and Paleik-Tada U road (0/0 to 7/0 mile) portions are chosen in this study. The failure patterns are classified depending upon the visual investigation along the study areas and identify the failure patterns of the two selected road portions. Map cracking, depression, corrugation, rutting, longitudinal cracking, pothole, edge failure, crocodile cracking, delamination, raveling and bleeding are found in the selected road portions. Along the selected portions, the pavements are damaged by the effects of weather, organic growth, traffic wear and damages as well as deterioration due to aging, excessive traffic loading of heavy trucks, insufficient pavement thickness, material failure, design faults and construction faults. The required overlay thickness is calculated by usi

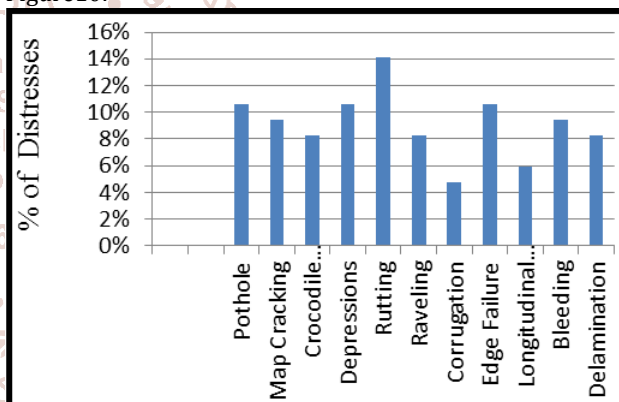
Figure10. Distress Percentages of Tada UAirport Road

In this study area, there are 85 distresses found in Tada UAirport portion. In this study, 9 potholes, 8 map cracking, 7 crocodile cracking, 9 depressions, 12 rutting, 7 raveling, 4 corrugation, 9 edge failures, 5 longitudinal cracking, 8 bleeding and 7 delamination are founded during the field survey. The number of distresses and distress percentages of pavement at proposed road are described in Table2 and Figure10.

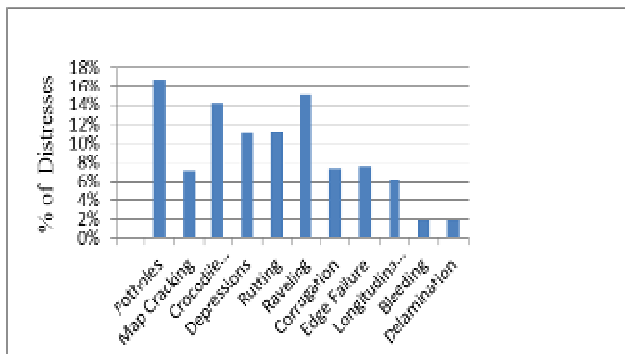
Figure 18. Distress Percentages of PaleikTada U Road

In this study area, there are 545 distress found in PaleikTada U road portion. This portion presents 7 miles from 0/0 to 7/0 miles. There are 91 potholes, 39 map cracking, 77 crocodile cracking, 60 depressions, 61 rutting, 82 raveling, 40 corrugation, 41 failures, 34 longitudinal cracking, 10 bleeding and 10 delamination. The number of distresses and distress percentages of pavement at proposed road are stated in Table3 and Figure18.
