Anatomical Study of Abnormal Odontoid Process for Crowned Dens Syndrome

Axis is the second cervical vertebra which is atypical. Dens or odontoid process of the axis forms the median atlantoaxial joint and also gives attachment to apical and alar ligaments. Apical ligament of dens is the remnant of embryologic notochord which may sometimes calcify causing compression, pain and restriction of neck movements as seen in crowned dens syndrome. 68 dried cervical vertebrae have been observed after excluding broken ones. 24 Atlas and axis vertebrae were examined where one axis showed a prominent dens. Morphometric measurements recorded with vernier calipers were 24.2 X 10.4 X 11.1 mms. The present study showed lengthier dens when compared with other studies. Etiology of crowned dens syndrome should be suspected in such cases. The apical ligament may be calcified at its attachment with the dens contributing to the lengthy odontoid process. Calcified apical ligament due to granular deposition gives crown like appearance of the crowned dens syndrome which commonly affects aged individuals. The present study reports an abnormal dens of the axis vertebra which may be due to crowned dens syndro

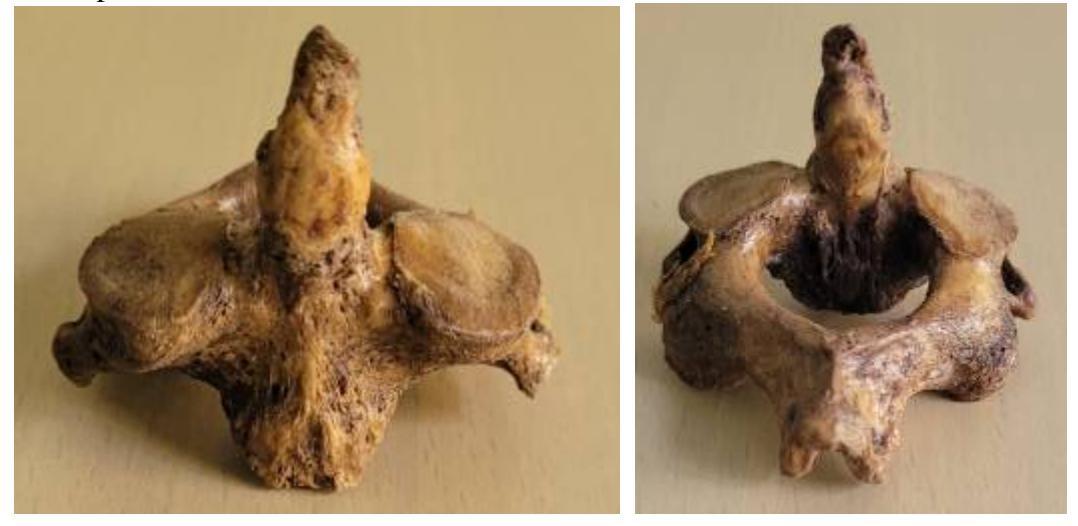
The following pictures depict the abnormal dens of the axis vertebra. Fig: 1 Anterior and posterior views of axis with abnormal dens

and 24 bones were evaluated for any morphological abnormalities. One axis vertebra was found to have abnormal odontoid process. Measurements were taken with a vernier calipers. Photographs were captured comparing with a normal dens.

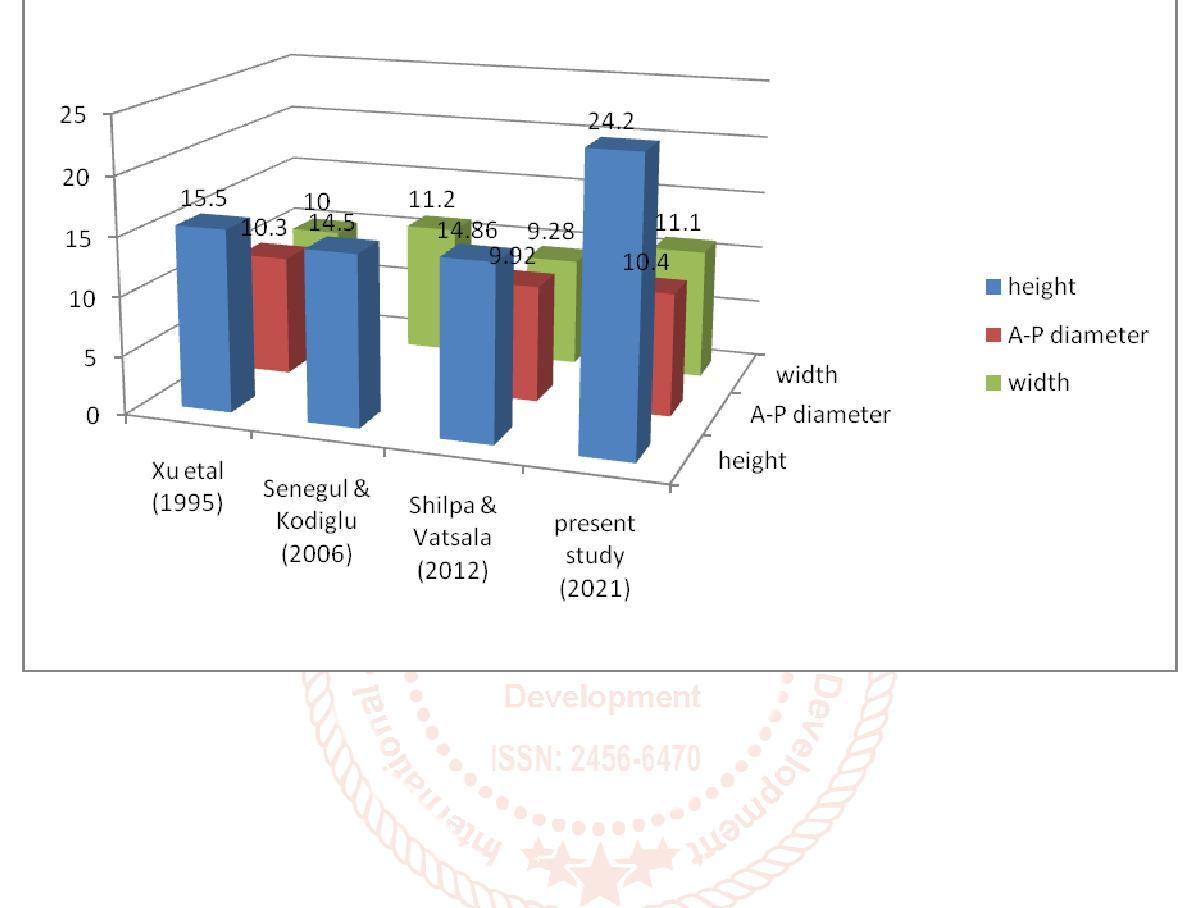
Graph 1: measurements of dens when compared with those of other studies
